THE DEVELOPMENT OF AN ADVANCED ANTI-ICING/DEICING
CAPABILITY FOR U. S. ARMY HELICOPTERS. VOLUME II.
ICE PROTECTION SYSTEM APPLICATION TO THE UH-1H
HELICOPTER

J. B. Werner

Lockheed-California Company

Final Report for Period 30 June 1973 - 30 June 1975

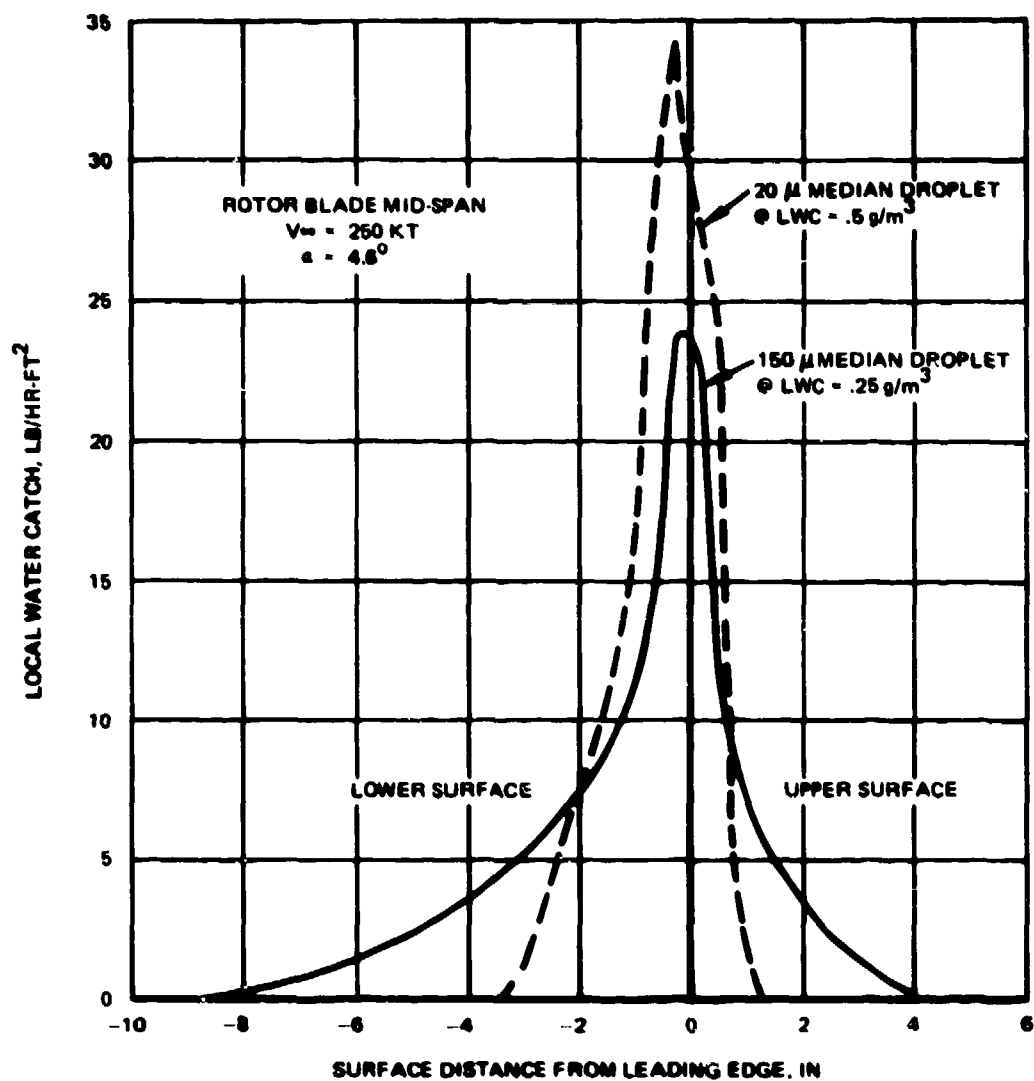
Figure 97 presents a comparison of the expected water catch distribution on the main rotor blade as would be experienced in natural icing with that occurring behind the tanker. It is seen that the large droplets result in double the total catch rate per foot of span for a given liquid water content; alternatively, the leading-edge catch rate is approximately 40 percent higher (for equal liquid water contents), and impingement extends approximately 100 percent further aft behind the HISS than would be experienced in natural icing. Although the catch rate

Figure 97. Local Water Catch Distribution for Two Droplet Sizes at the Liquid Water Content Required for Equivalent Total Water Catch.

behind the HISS is double that for natural icing, the severity of icing is generally evaluated at the leading edge; and thus tanker icing could be taken as at least 40 percent more severe than natural icing.

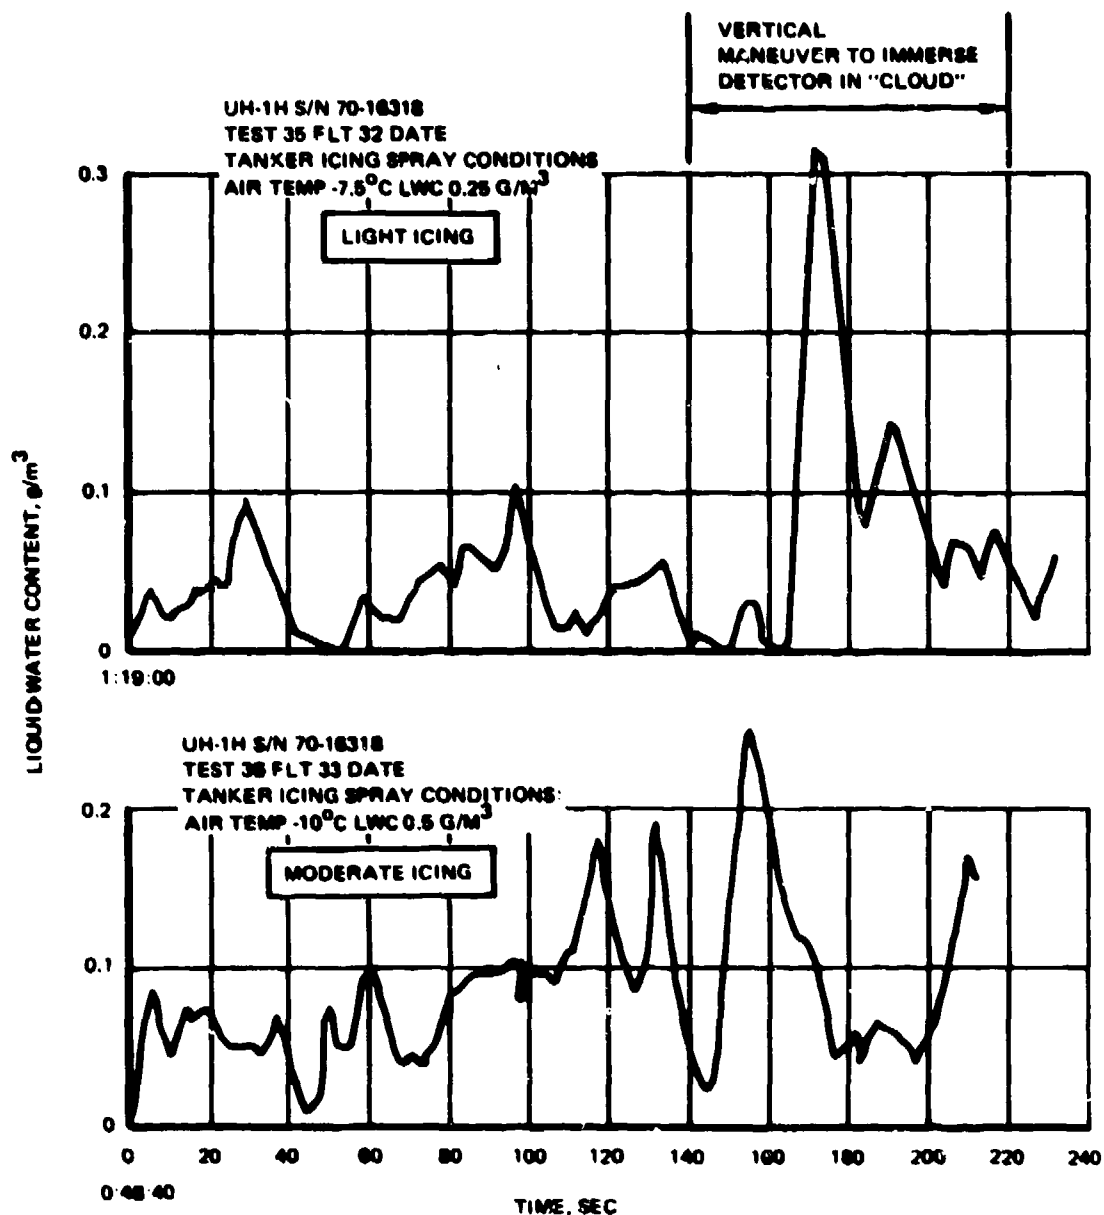
As discussed in Section 2.4, two ice detector sensing units were mounted on top of the fuselage (Figure 16). Fundamentally, these units are ice detectors, with their output signals processed as appropriate to provide indications of liquid water content. Figures 98 and 99 show the response of the ultrasonic unit in several different spray cloud densities. As previously noted, the HISS cloud has a vertical extent of the order of 5 feet; this results in the ice detectors' normally being positioned near the edge of the cloud when the main rotor is positioned near the center (Figure 75).

Thus, the detectors will indicate a below-average cloud liquid water content. Figure 98 does show the effect of a penetration of the sensor through the cloud and provides a measure of the vertical distribution. The nominal liquid water content noted on the figures is obtained from the calibration data for the HISS.

These data show that the ultrasonic unit provides a very rapid response to local icing severity conditions and that it apparently yields at least a good measure of relative icing severity. Further testing under natural icing conditions is needed to establish its usefulness in providing signals for the modulation of the rotor deicing system.

Figure 98. Liquid Water Content Meter Performance.

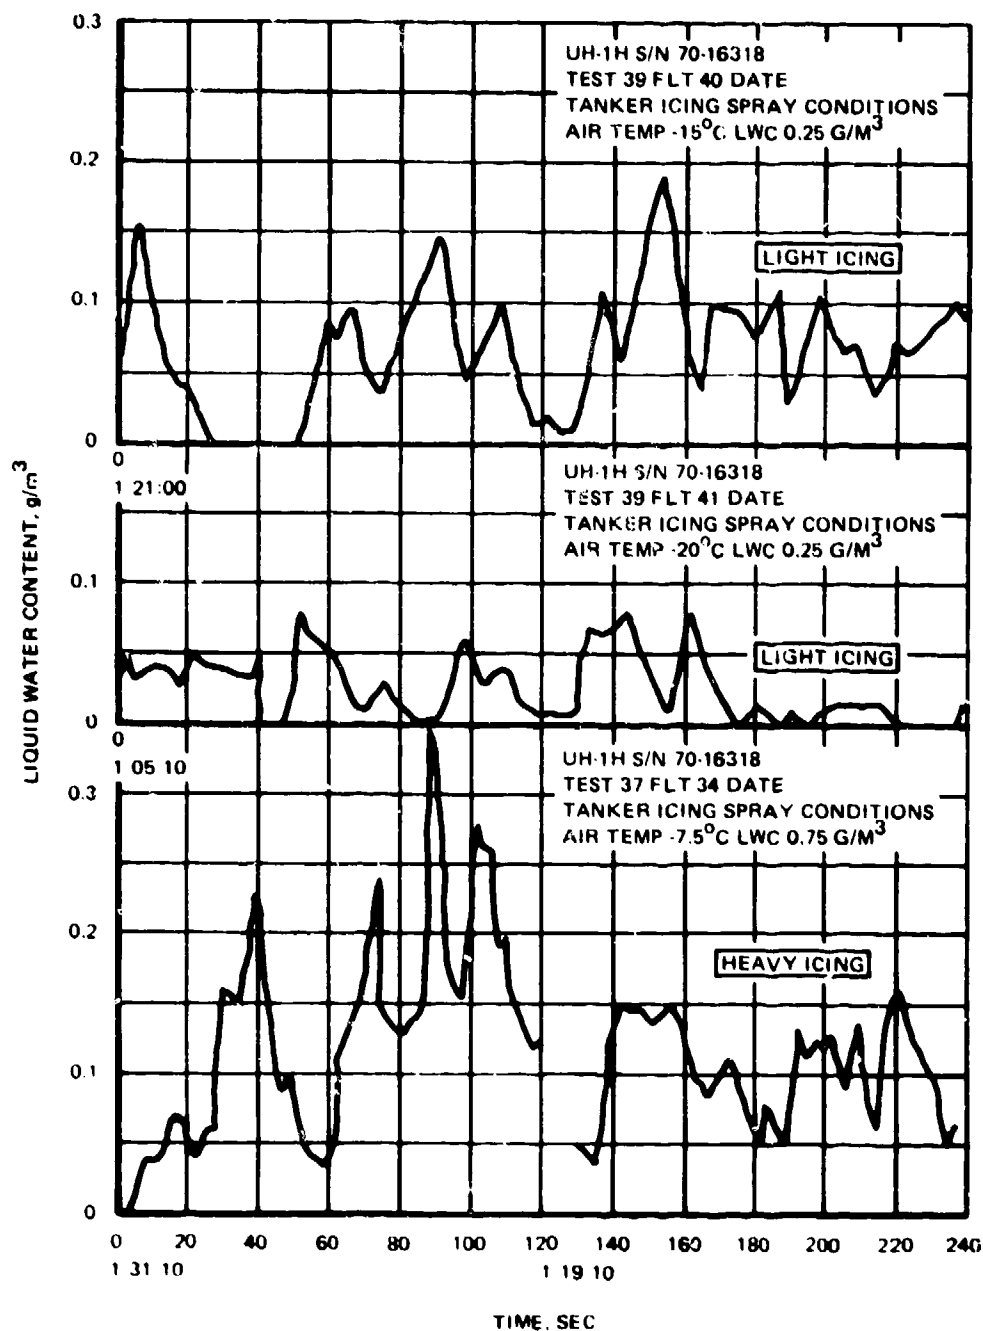
Figure 99. Additional Liquid Water Content Data.

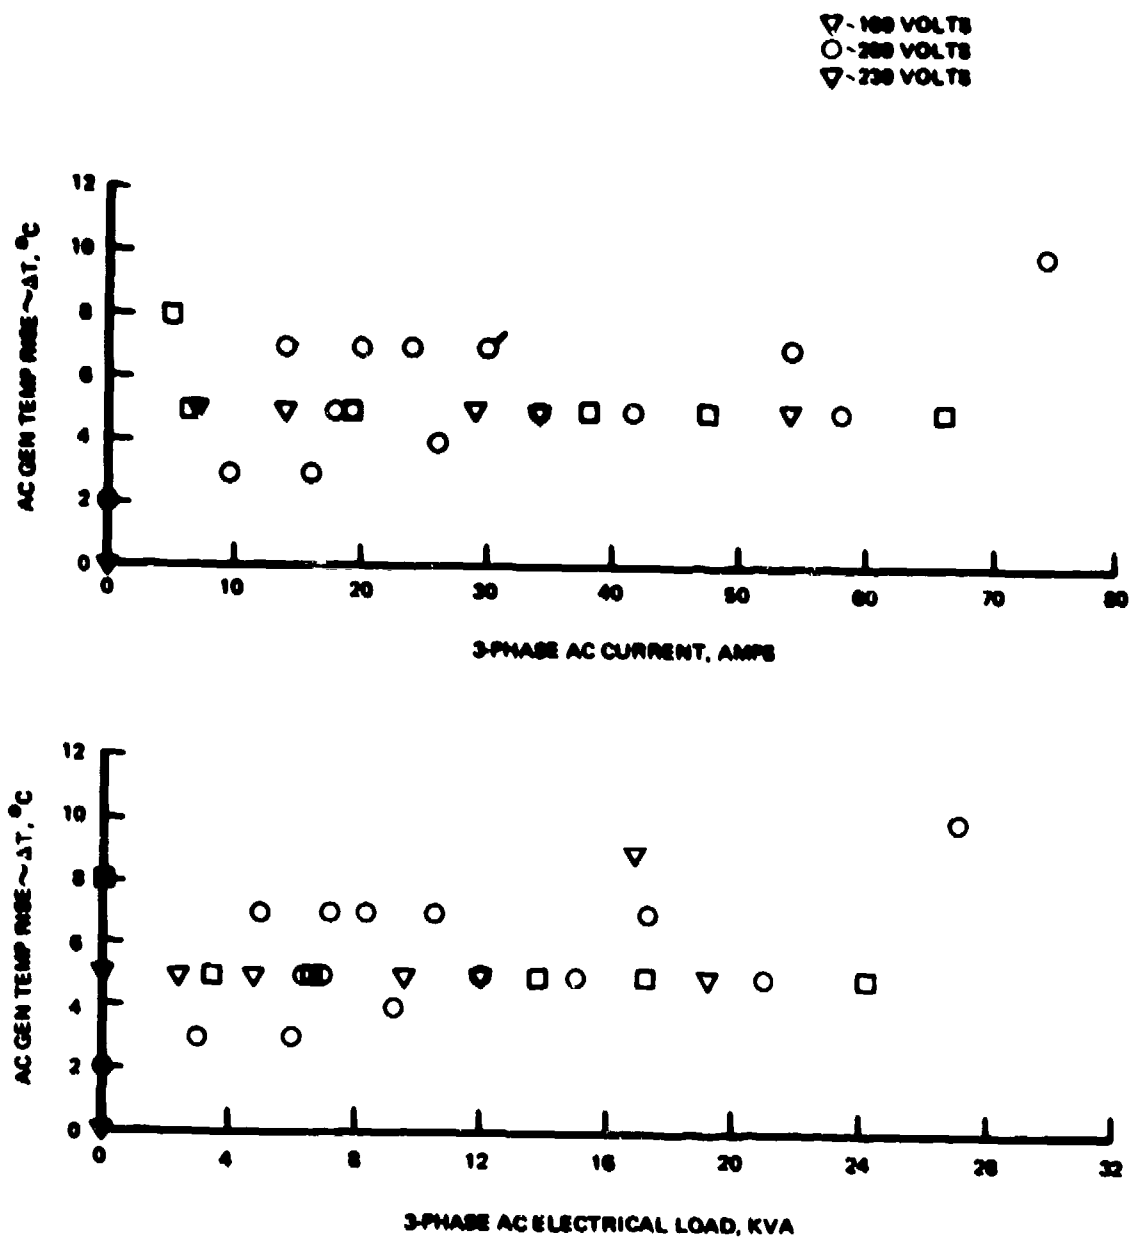
Ground tests were conducted using a load tank to evaluate the cooling characteristics of the ac generator under varying electrical loads at voltage levels of 160, 200 and 230 volts. The results of these tests are presented in Figure 112 and indicate that the maximum temperature rise

Figure 112. Temperature Rise of AC Generator Cooling Air With Varying Electrical Load.

experienced was 18°F. The maximum inflight temperature rise experienced during this period of testing was 27°F. It would be expected that the temperature rise is proportional to the generator output instead of being almost independent. The measured inlet temperature was noted to be 20-30°F above ambient, and it may be that this reading for some reason is too high.
